TECHNICAL REPORT ECOM-01424-F

LOW COST INTEGRATED CIRCUIT TECHNIQUES

FINAL REPORT

PHILCO-FORD CORPORATION
Lansdale, Pennsylvania

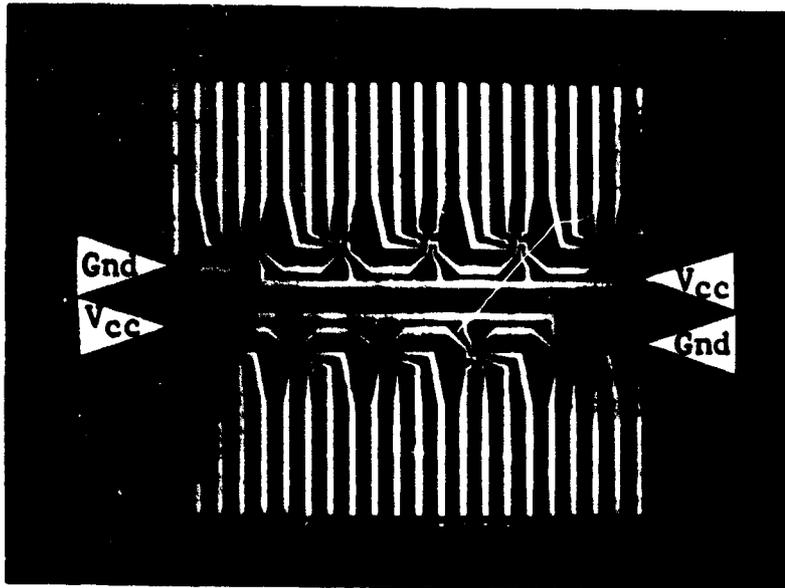
Figure 1a. Printed circuit board substrate for Final Exploratory Development Model.

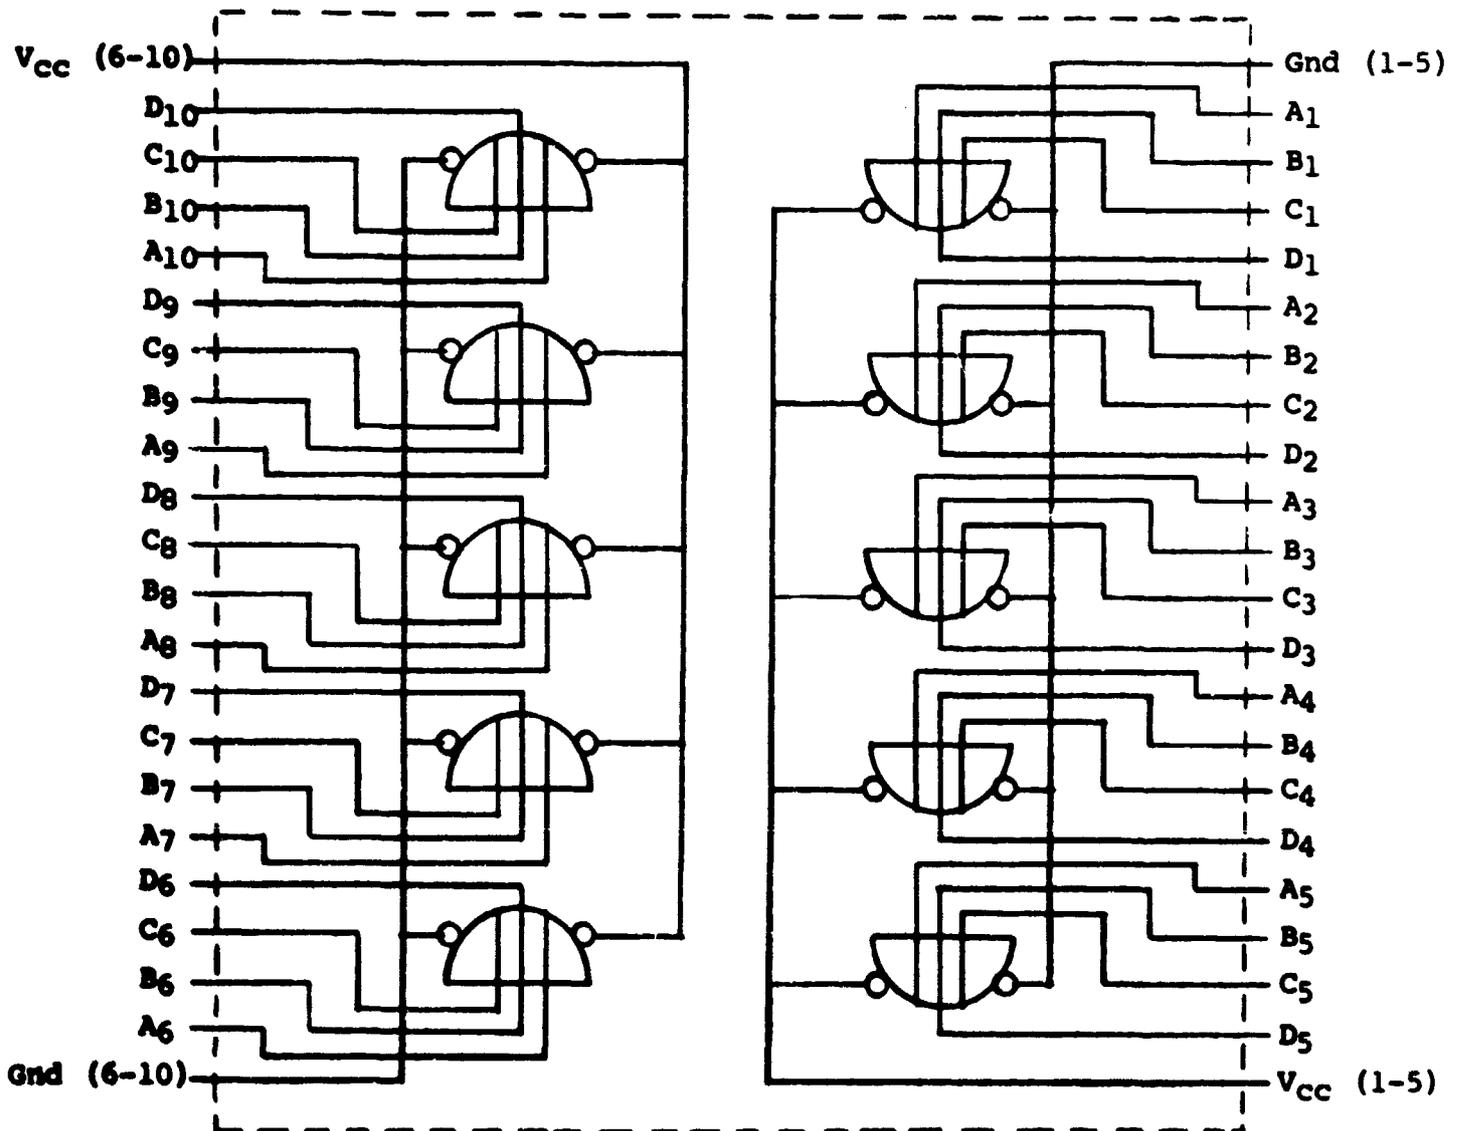
Figure 1b. Schematic diagram of Final Exploratory Development Model (array of ten 3-input gates).

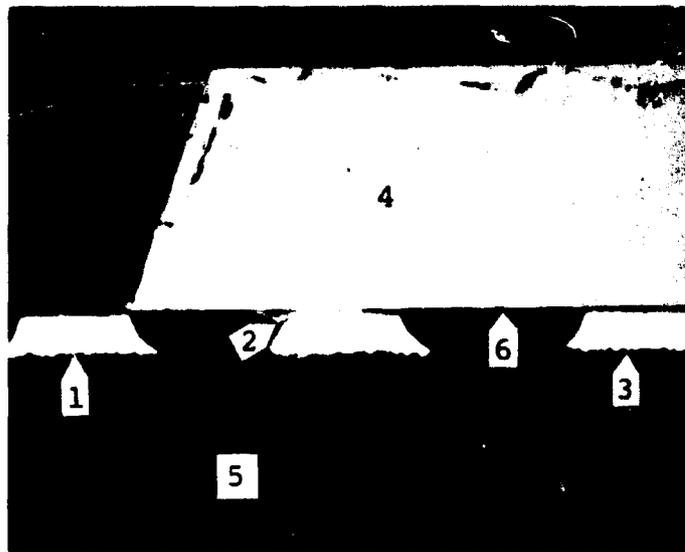
Figure 2. Cross section of portion of Final Exploratory Development Model, illustrating crossunder.

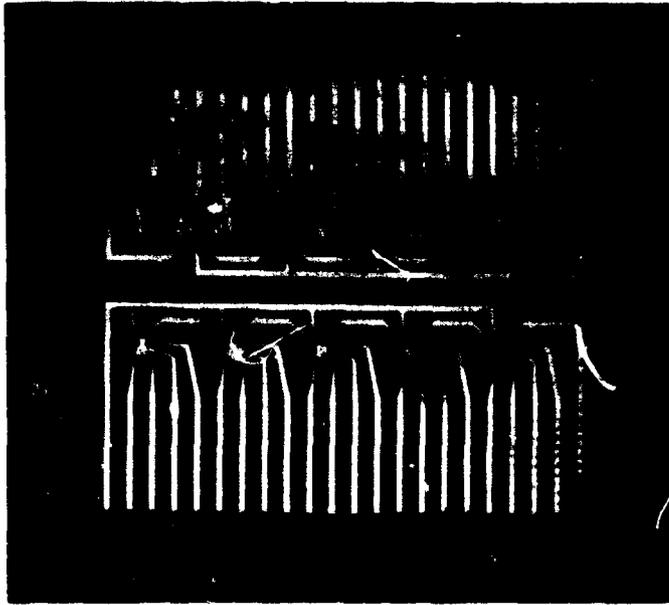
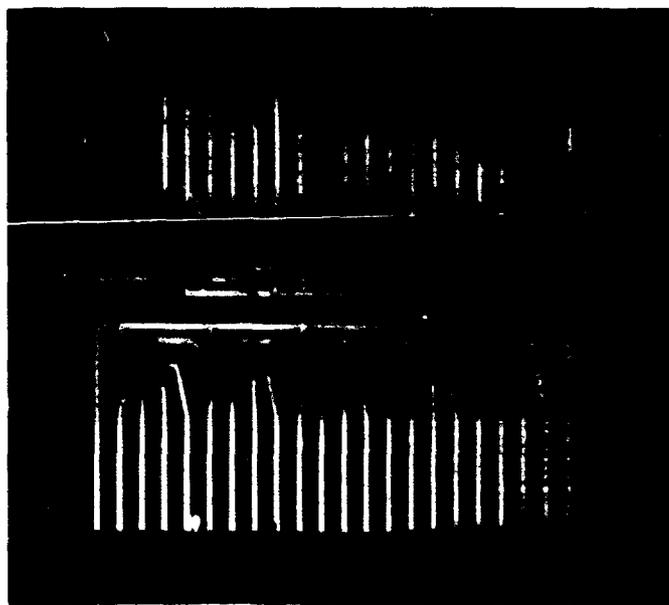
Figure 3. Final Exploratory Development Model.

a. Prior to application of epoxy protection.

b. Completed.

As a demonstration of the processes developed during the contract period, four (4) integrated circuits, final exploratory development models, were constructed. These models each contain ten 3-input RTL gates encapsulated and assembled onto a single board. A photograph of the substrate used for the models is shown in Figure 1a. A schematic, consistent with the physical layout of the circuit, is given in Figure 1b. Note that common supply and ground leads are provided for the gates and all inputs are available at two edges of the board. It can be seen in Figure 1a that the common ground is accomplished by running a copper line under the chips. Figure 2 is a photomicrograph of the cross section of a portion of the final exploratory development model showing the location of the crossunder. A completed final exploratory development model is shown in Figure 3.

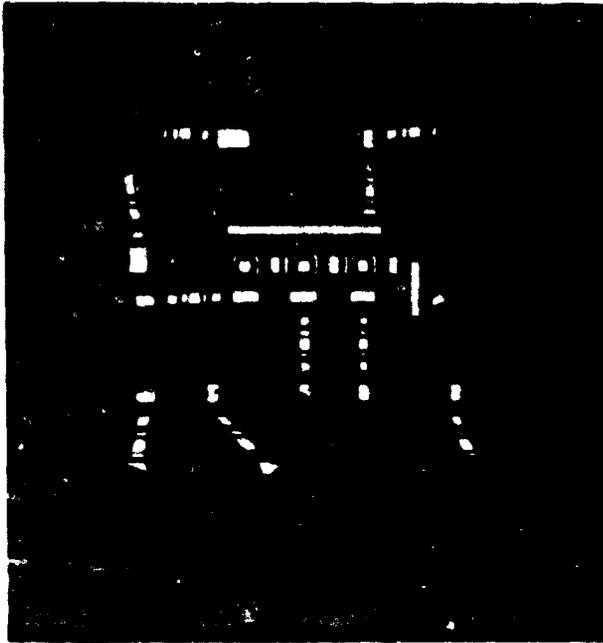
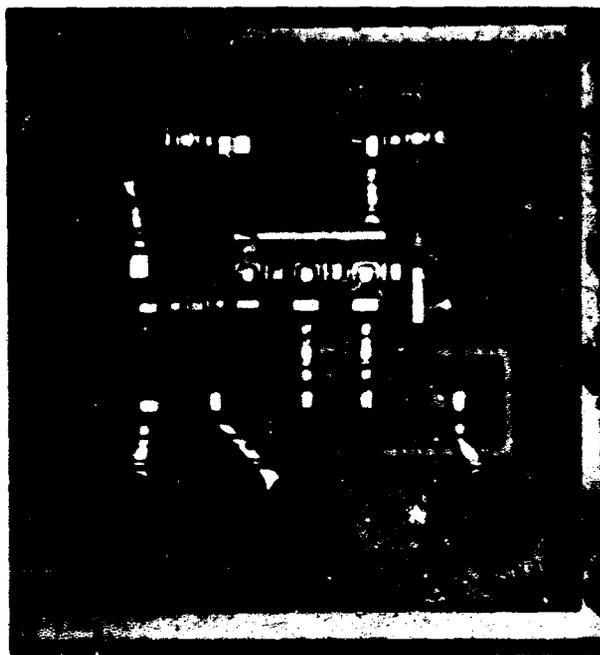
Figure 4. RTL gates with (top), and without (bottom), glass encapsulation.

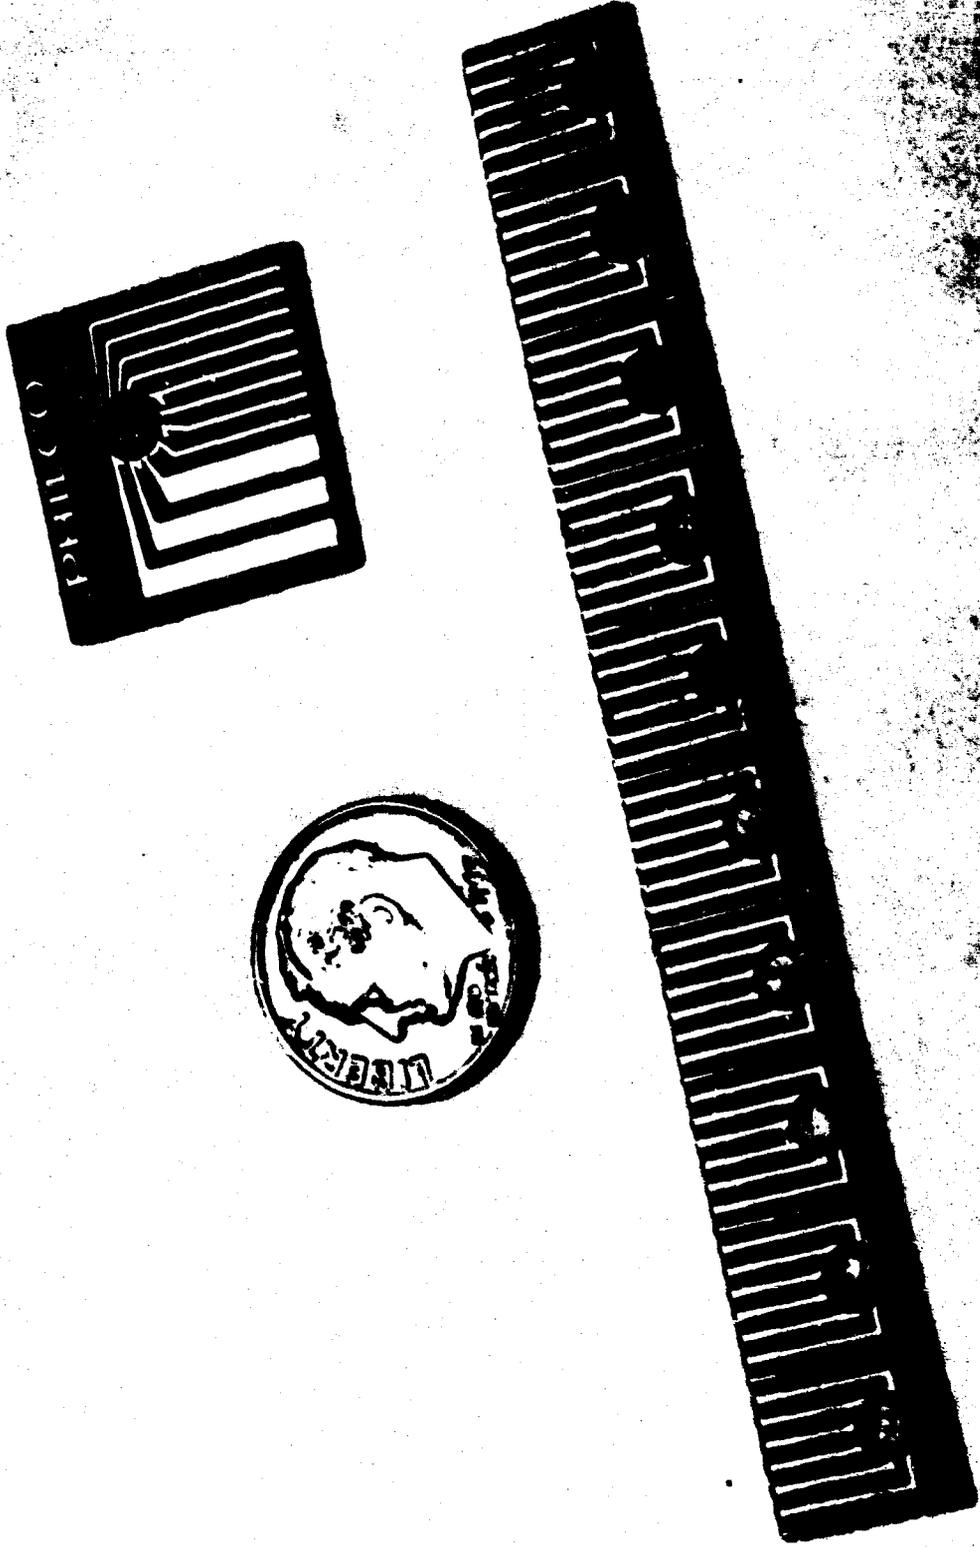
Figure 5. A 10-chip array of RTL gates.

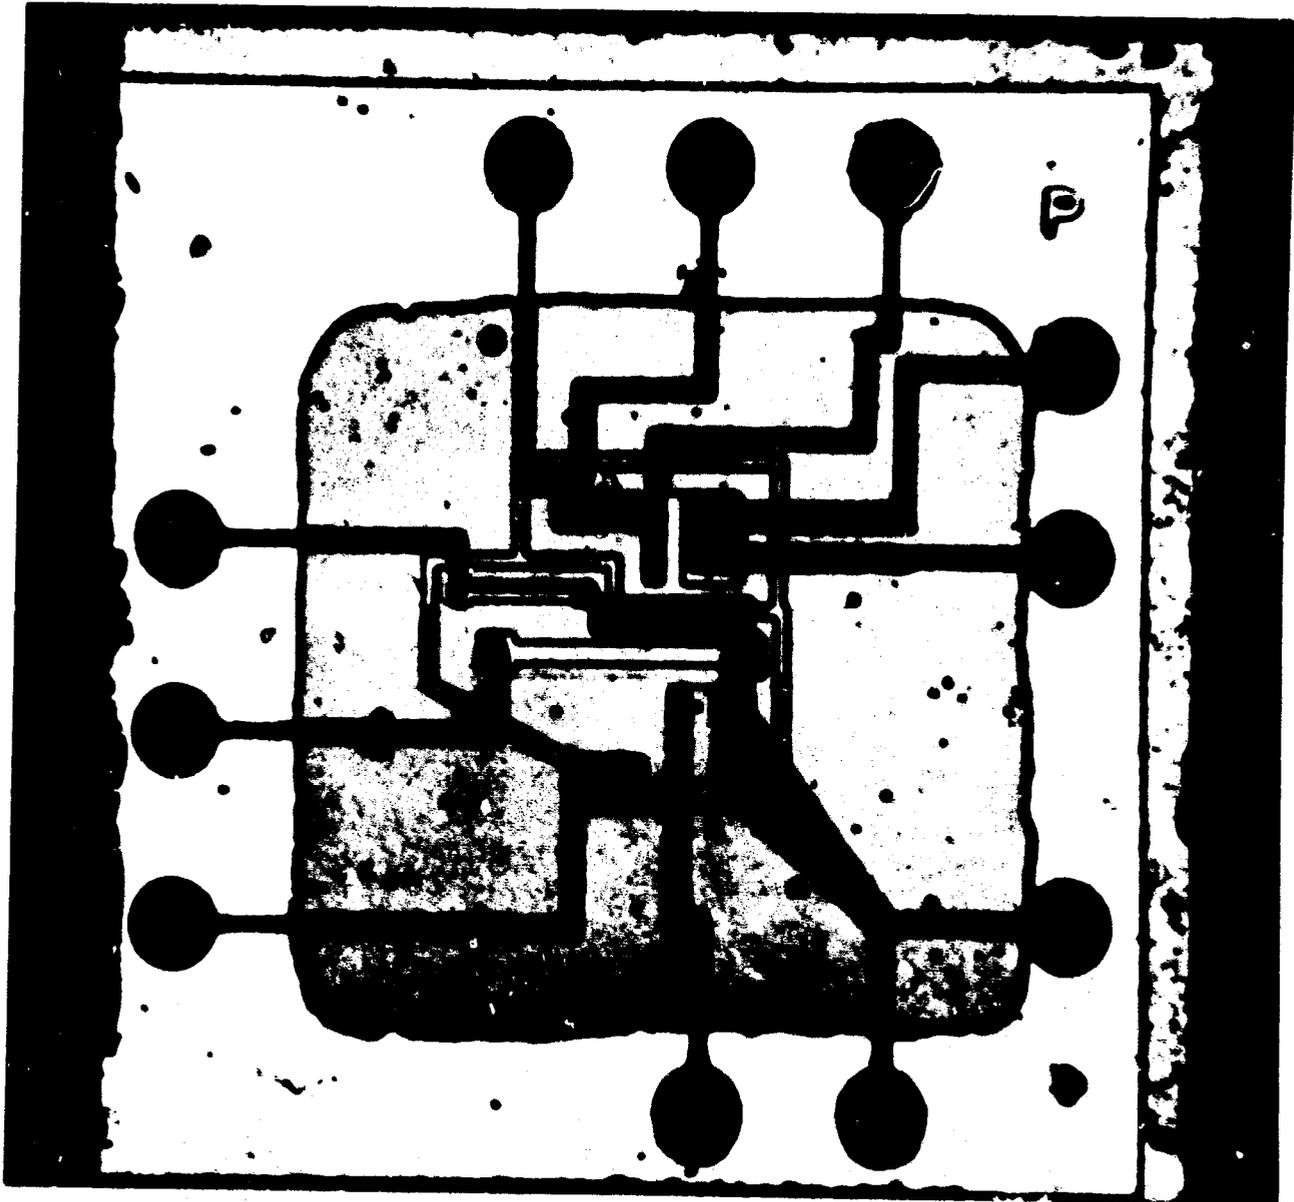
Figure 6. Silicon microcircuit chip encapsulated with evaporated glass.

Our initial approach to batch passivation was tungsten coil evaporation of Pyrex 7740 glass through metal masks onto the silicon wafer. Figure 6 is a photograph of a chip made with this technique. At the same time, other techniques for the deposition of glass films were being evaluated. By the third quarter of the program considerable data had been accumulated which indicated that vapor plated SiO_2 is better than evaporated glass in many respects. In particular, the vapor plated SiO_2 is superior as follows:

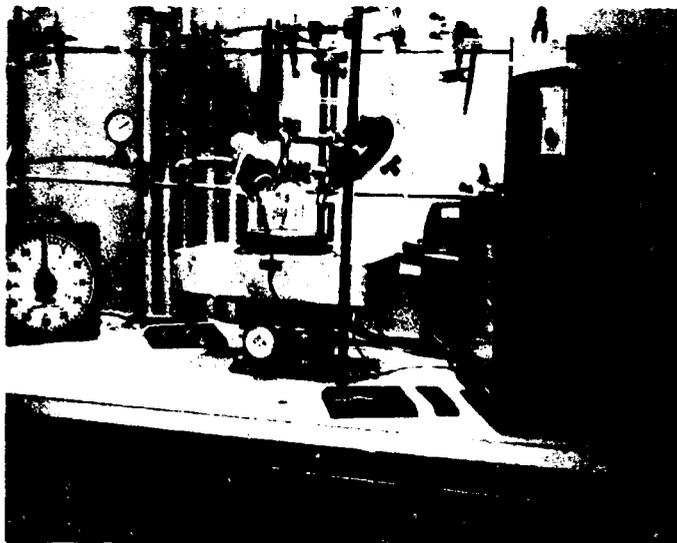
Figure 7. Two views of the SiO_2 vapor plating system.

Vapor plating is a relatively simple procedure and is accomplished by placing the integrated circuit wafer on a heated substrate beneath a nozzle dispensing a mixture of SiH₄ diluted with dry N₂ and mixed with O₂. This mixture flows down onto the wafer where the hot surface causes the reaction to occur, depositing a film of SiO₂. The apparatus is shown in Figure 7. The connection

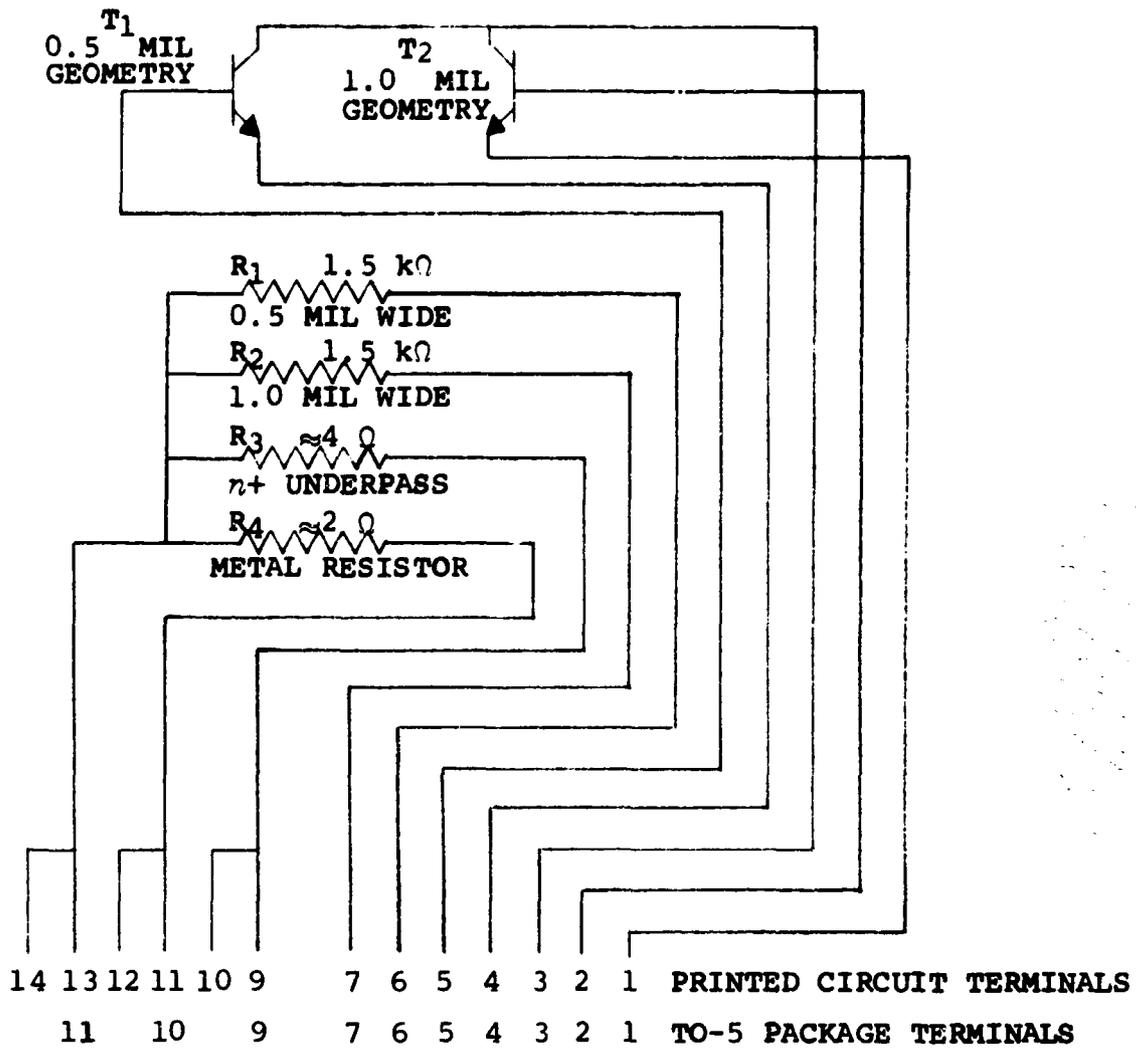
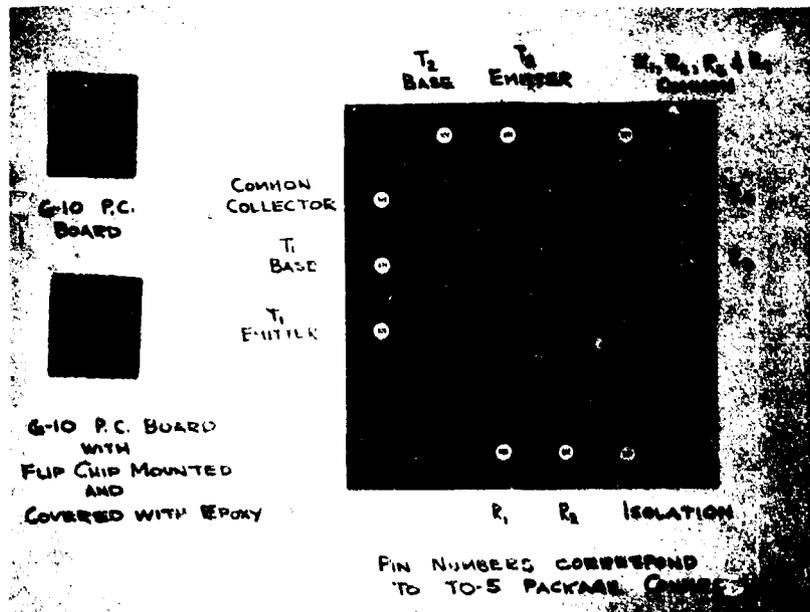
Figure 9. Test module.

a. Schematic diagram.

b. Photograph.

Terminations were made so that all components could be measured independently. Figure 9a is the schematic diagram of the test module. A photograph of a test module with circuit connections identified is shown in Figure 9b.

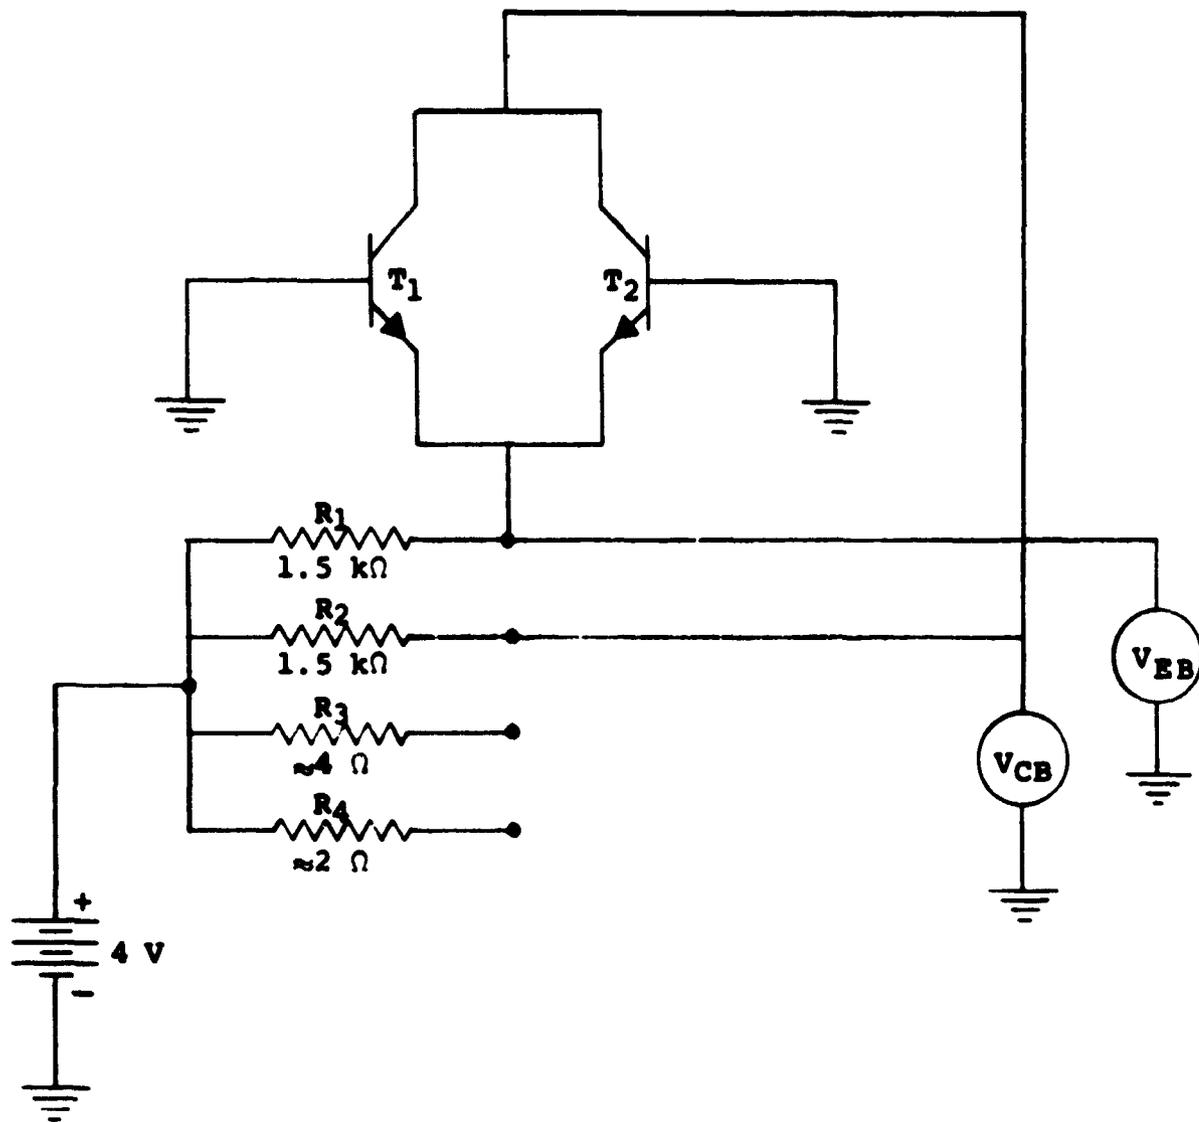
Figure 10. Reverse bias test circuit.

1. Thermal Shock, per MIL-STD-750, Method 1056.1, 0°C to 100°C, 5 minutes at each temperature extreme, immediate transfer.
2. Mechanical Shock, per MIL-STD-750, Method 2016.1, 1500 G, pulse duration 0.5 ms, five (5) blows in each of three (3) planes*.
3. Vibration, Variable Frequency, per MIL-STD-750, Method 2056, 20 G, four sweeps from 100 to 2000 to 100 cps in each of three (3) planes*.
4. Constant Acceleration, per MIL-STD-750, Method 2006, 20,000 G, three (3) planes*.
5. Moisture Resistance, per MIL-STD-750, Method 1021.1, except that initial conditioning was not performed.
6. Moisture Resistance, per MIL-STD-750, Method 1021.1, with bias applied as per Figure 10.

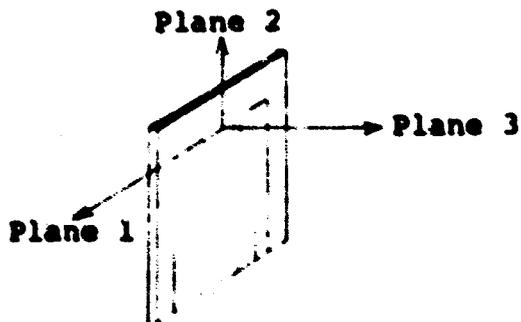
**ENVIRONMENTAL TEST PLANES FOR SHOCK,
VIBRATION AND CONSTANT ACCELERATION**

*See sketch at bottom of Table II (page 35) for definition of planes.
